EVALUATION OF ELECTROSTATIC PROBE
TECHNIQUE FOR DETECTION OF PARTICLES
EMITTED DURING TURBINE ENGINE
DISTRESS

Air Force Aero Propulsion Laboratory
Wright-Patterson Air Force Base, Ohio

November 1974

3. REPORT TITLE		
EVALUATION OF ELECTROSTATIC PROBE TECHNIQUE FOR DETECTION OF PARTICLES EMITTED DURING TURBINE ENGINE DISTRESS		
4. DESCRIPTIVE NOTES (Type of report and inclusive dates)		
Final - 15 Jan 74 - 15 Mar 74

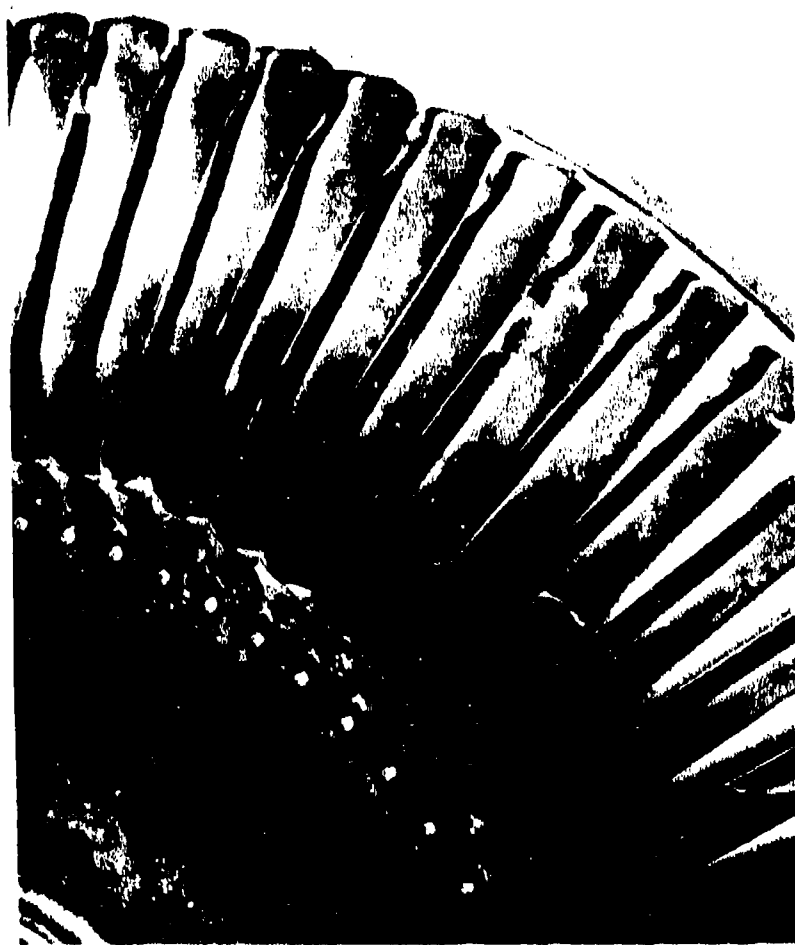
Figure 5. Rub Area on Stage 2, LP Turbine

Stage 2 LP turbine rub was achieved by inserting the rod through a spare pressure/temperature port in the exhaust case as shown in Figure 4. The distress location giving the best results as far as particle generation and convenience was at a position on the trailing edges of the stage 2 LP turbine blades about 2" from the shroud. This area is shown in Figure 5, which is a photograph of the trailing edge side of this stage after all testing had been completed. Some wear on the blades due to the rub can be observed in this photograph. Due to the greater hardness of the blade material, most particle generation was due to material loss from the rub rod. Figure 32, presented later, shows the typical appearance of the rub rod tip after a successful rub test. The flaired appearance of the tip was produced by the frictional heating and pounding effect of the rotating blades. Typically, 0.5 to 3.5 grams of rod material was worn away during testing. Particle generation was verified by observation of the area behind the exhaust through a porthole in the test cell wall. During the successful rub attempts, glowing streaks of particles could be observed exiting the engine over a region large enough to ensure particle impact with one or more probes. Although a few particles did stick to the probes, most particles would not be expected to plate out on the probe surfaces since the gas temperature was well below the material melting point and the particles would lose some heat to the exhaust gas.

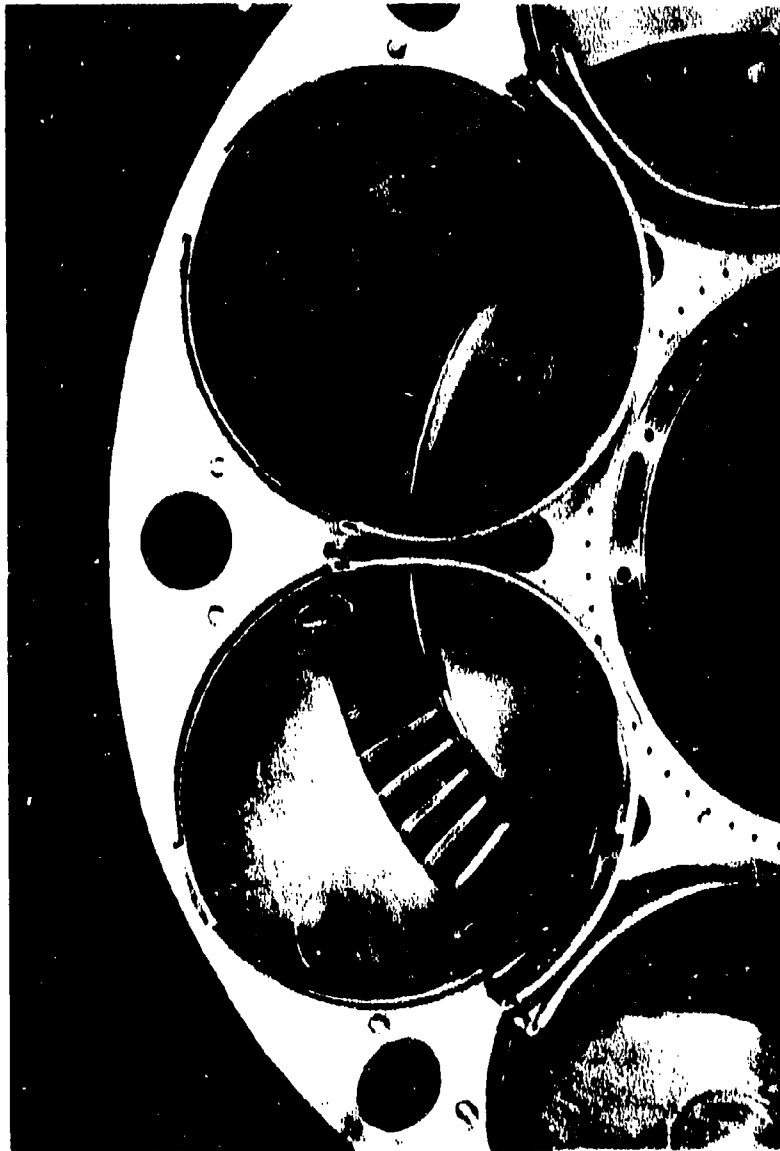
Figure 8. Plating of Burn Rod Material in Transition Duct

Particle generation due to burning or melting was achieved in the same manner as described above, except that the location was the #1 combustor can. Figure 7 is a diagram of a J57 combustor can showing the location of the test points for Tests 7 and 8. Results for Test #6 were not satisfactory as the steel rod did not melt nor did the surface oxidize sufficiently to cause the surface to peel and flake off. The distress site was therefore moved to the region indicated for Test #7 and #8, which is closer to the fuel nozzles and has less cooling air entering the combustor can. Even here, however, satisfactory results were obtained only for a non-high temperature steel material. The material used in these tests was Type 1020 cold-roll steel (same as for the rub tests) unless otherwise stated in the individual test results. A stainless steel rod exhibited some surface burn, but no particles could be seen exiting the engine. Approximately 15 grams of rod material was melted and/or burned away in the successful attempts. (This compared with about 30 grams lost in an actual case of 1st stage turbine vane burn reported in Reference 6, a case in which the probe appeared to give an indication of distress.) Particle emission in these cases was observed to be rather erratic and with particles exiting the engine in spurts. Figures 8 and 9 show that much of the material was plated out on surfaces in the transition duct and turbine stages.

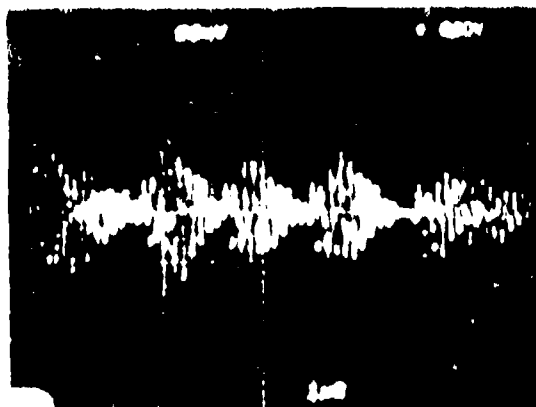
Figure 23. Noise Pulses 6 MHz, Test #3a

COMMENTS: Rub on rod was as shown in Figure 21. Visible particle emission observed at idle. No other rub was judged to have occurred, based upon inspection of test hardware. 915 counts were recorded on probe D30 in the 5 minute period just after idle, but waveforms indicate electrical interference. Also, the counts recorded during the test point setting (90%NRT) were believed due to interference. See the waveform photos and comments of Figures 22 and 23.

Test: 3a
Date/Time: 25 Jan 74, 1100
Engine: J57-37
Cable/Term.: RG-62/93 ohms
Probe: A2
V/Div: 50mv
T/Div: 1 microsec.

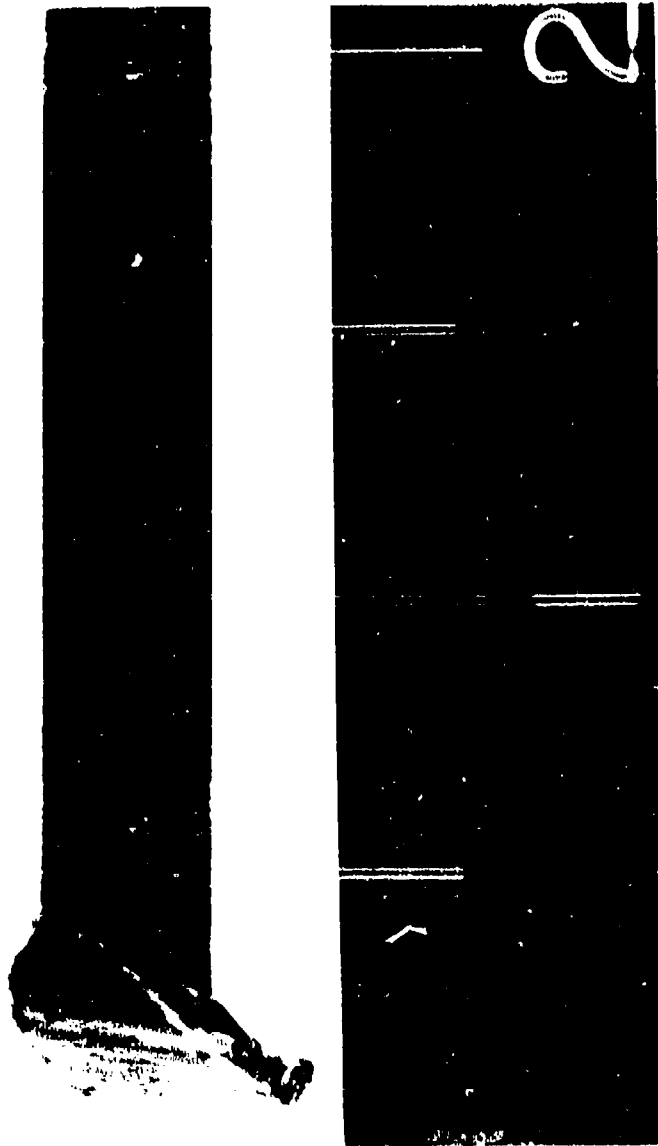
Figure 32. Rub Rod, Test #5

Approximately 0.4 grams of rub rod material was rubbed away at the test point setting of 95%NRT. (see photo of rod in Figure 32.) All counts occurred at the test point setting. No signal waveform photos were taken in direct correlation with these counts. The photos of Figures 34 and 35 are typical of what was seen on the scope, though not necessarily at the time the counts were recorded nor on the same probe.

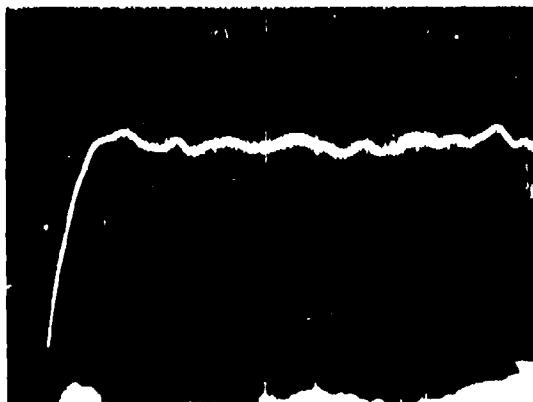
Figure 35. Negative Pulse Into 1 Mohm (Expanded), Test #5

Remarks: Probe A6 was connected to MCA#1. The MCA#1 did not count these pulses because it was set to count positive pulses. Also, the amplitude was less than 50mv when the cable was terminated into 93 ohms. This photo shows the type of signals seen during rub-rod insertion, though similar pulses were observed during non-distress periods. (See also Single trace below.)

Test: 5
Date/Time: 11 Feb 74, 1030
Engine: J57-37
Cable/Term.: RG-62/1 Megohm
Probe: A6
V/Div: 50mv/AC coupled
T/Div: 2ms

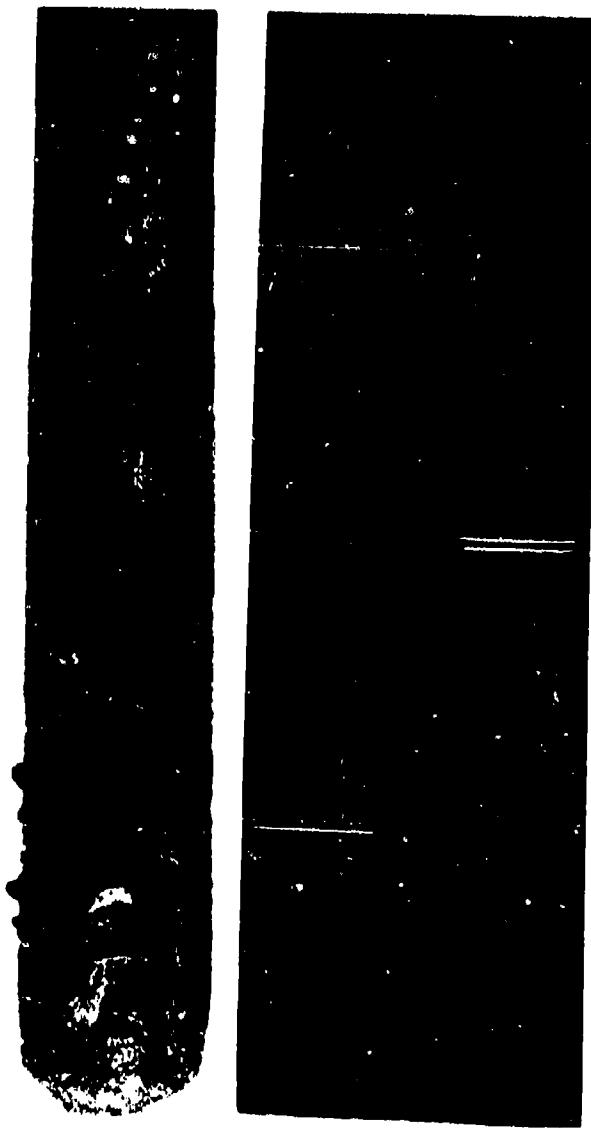
Figure 44. Burn Rod, Test #8b

COMMENTS: Rod was inserted at about 60%NRT in an effort to determine if burn would take place at this setting, thus also serving to clarify results of test 7b. No significant material loss was observed in post-test inspection, but some pitting and oxidation was noted. (See Figure 44.) No particle emissions were observed, indicating also that detection would not be expected.

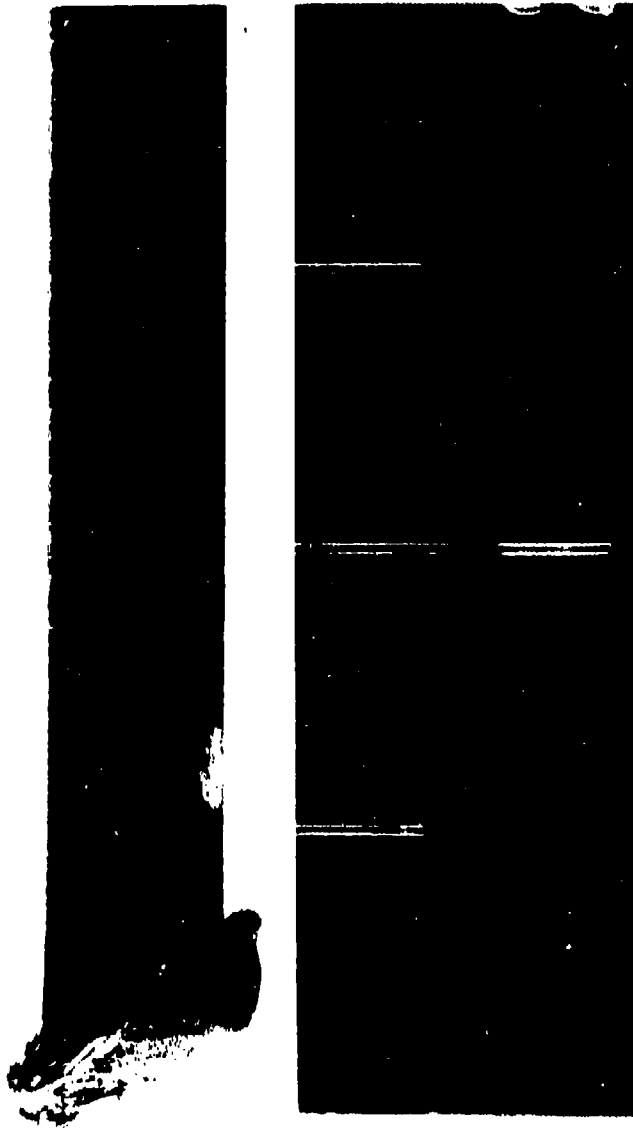
Figure 46. Rub Rod, Test #9

COMMENTS: For this test, electrostatic probes were electrically biased at a negative potential of about -67 volts in an effort to enhance static discharge signals as has been observed in other testing on J57 engines. Otherwise this test was comparable to tests 4b and 5. About 0.8 grams of material was rubbed away at 95%NRT. (Figure 46.)
